Rock Hill Board of Historic Review

Regular Public Hearing
September 2, 2021
6:00 p.m.

Request: Replace porch decking, side porch columns, and porch roof entablature elements with duplicates of alternative materials

Request: Construct columbarium addition on front façade
Address: 234 East Main Street
Tax Map: 627-18-06-001
Owner/Applicant: First Presbyterian Church

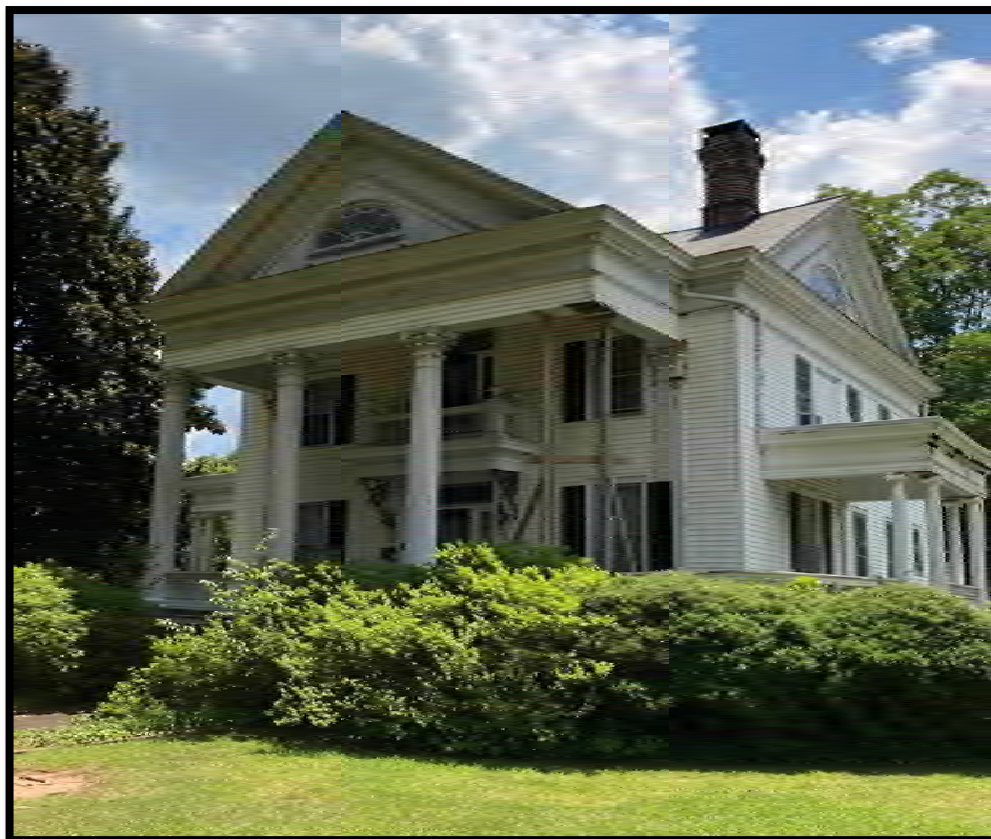
The owner and applicant, Addie Mayfield Rutledge, is requesting to replace all the existing porch decking, side porch columns, and sections of the entablature above the side porches as needed with alternative materials in the same profile and dimensions as the existing. The main body of the entire structure is covered with vinyl siding and the porch decking was replaced in 1994. The large column on the front is currently undergoing replacement as approved by the Board in 2019.

Staff recommends approval of the request to replace the existing porch decking, side porch columns, and damaged cornice molding trim with alternative materials with the conditions that the materials match in dimensions, configuration, and profiles as the existing components, be painted as soon as possible after installation, and if at all possible, the ionic capitals on the columns remain in place.

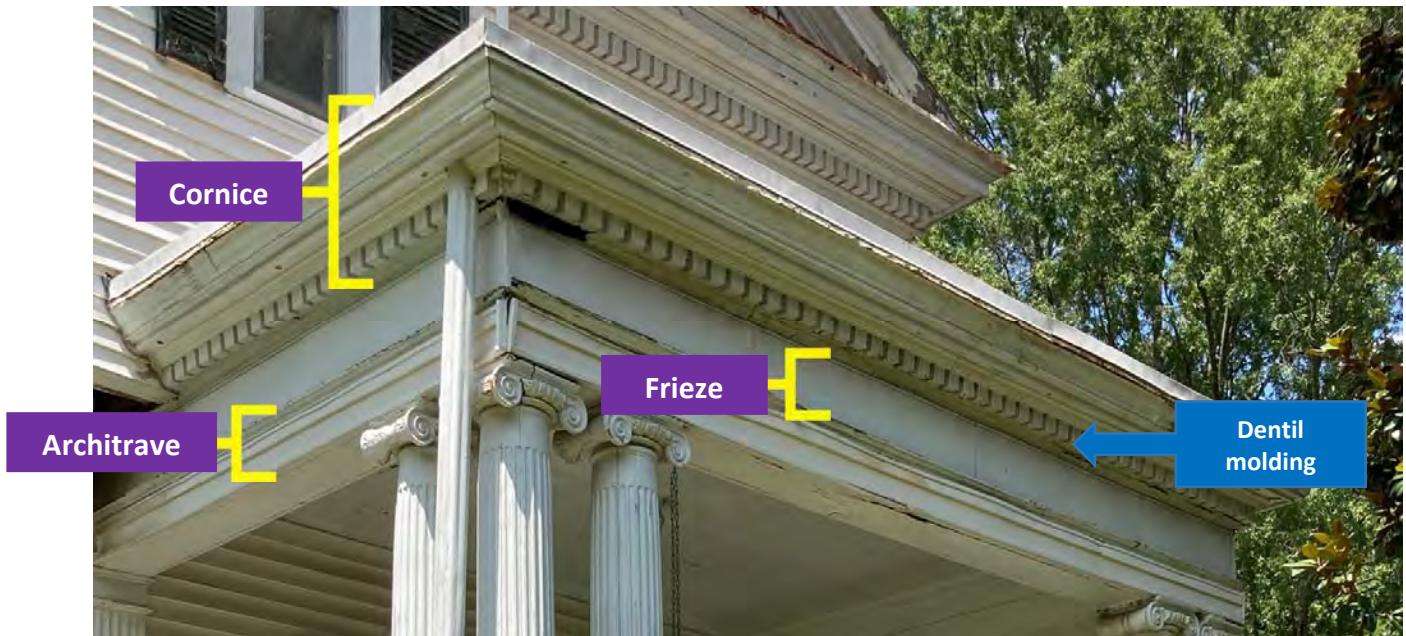
Porch located on the left side facing the structure

One of the main aspects of the Neoclassical architecture is the use of Ionic entablature to provide details along the rooflines of the main structure and the side porches. The entablature is made up of three sections: a decorative cornice at the top, a simple frieze area, and a detailed architrave.

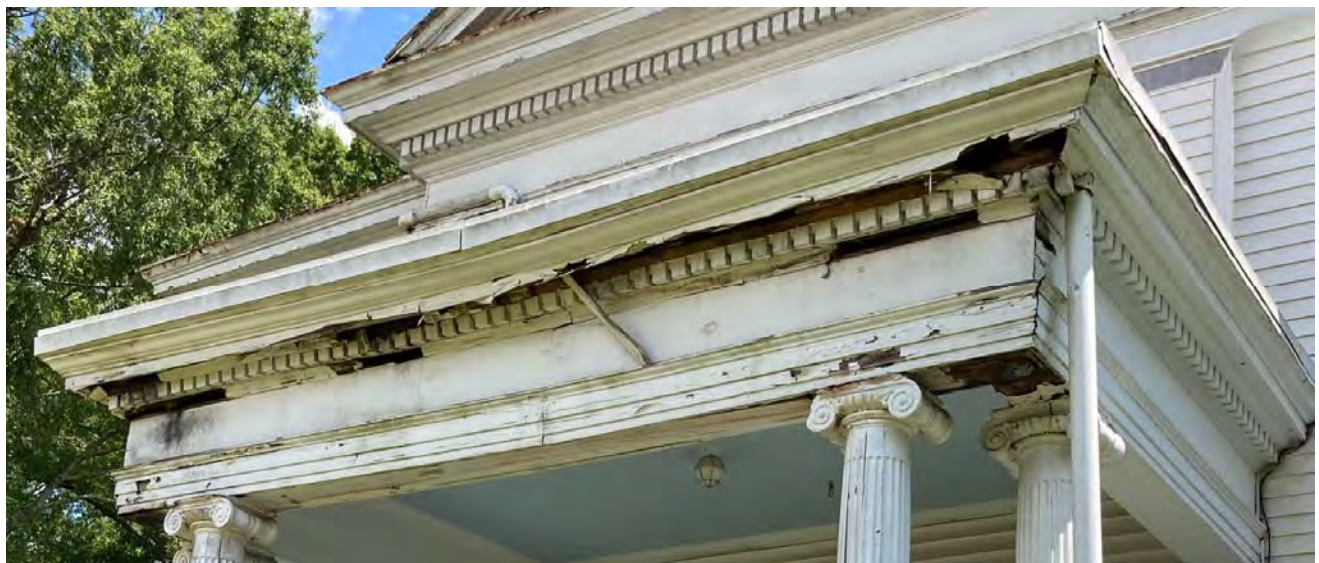
Porch located to the right of the structure: Along the top cornice area, there is extensive deterioration of the trim molding above and below the dentil molding. The frieze board is in fair condition, and sections of the architrave need repair. The applicant is requesting to replace only those portions that are extensively deteriorated with an alternative material that would have the same appearance as wood and would be of the same profile, detail, and dimensions.

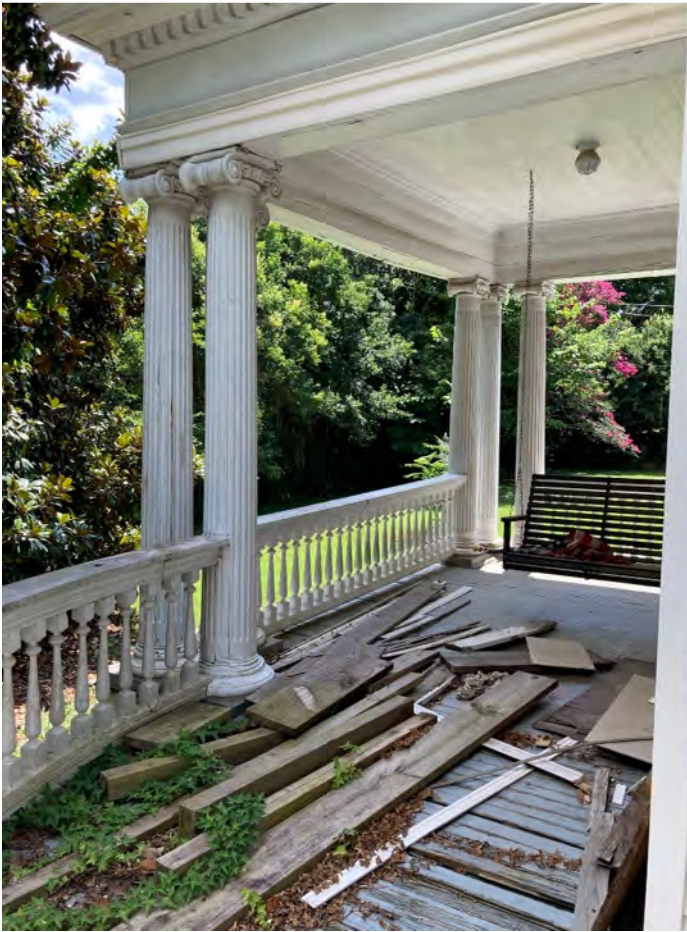
Side porch – left

The columns requested for replacement include those located on the side porches on the secondary facades. The applicant is proposing to install fiberglass columns that duplicate the appearance of the existing columns, which are fluted with ionic capitals and round bases. In looking at the current columns, it appears that several columns have been replaced as evidenced by construction methods not consistent with those of the early 1900's, specifically:

- varying widths of the smooth areas below the fluted sections;
- the appearance of round vents; and
- noted separation between the joints indicating that rather than solid wood, the columns are composed of glued together segments of wood slats.

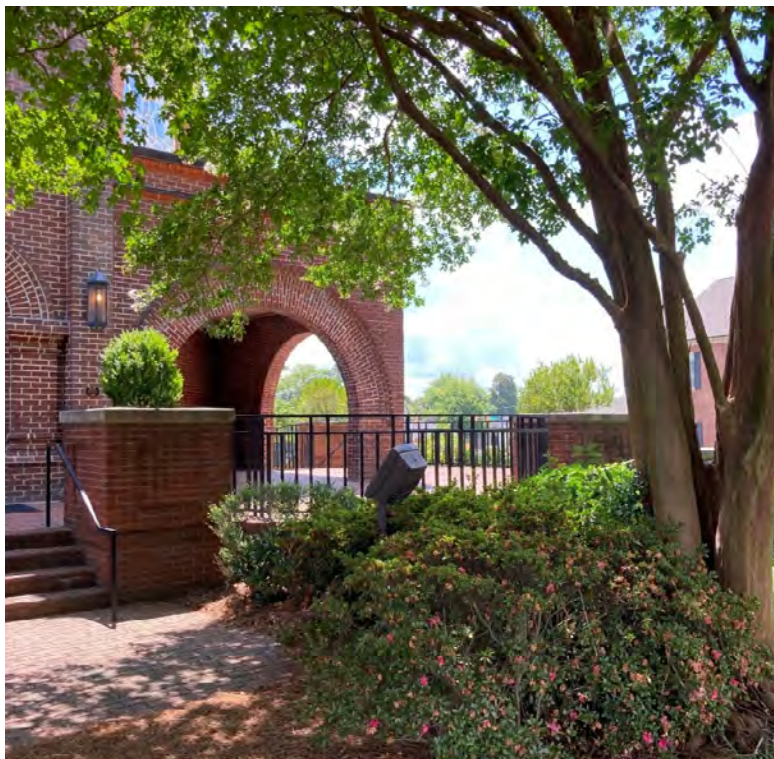
Portico and terrace – 2021
(City of Rock Hill photo)

First Presbyterian Church is requesting to install a columbarium area in the portico area and the two terrace areas of the East Main Street entrance to the church sanctuary.

The proposed change will have a slight effect on the exterior appearance of the primary façade as one wall in the portico portion of the main building will be fitted with a columbarium structure and the iron railing on both terrace areas will be replaced with columbarium structures proposed to face the interior.

Staff recommends approval of the request to construct the columbarium structures as proposed.

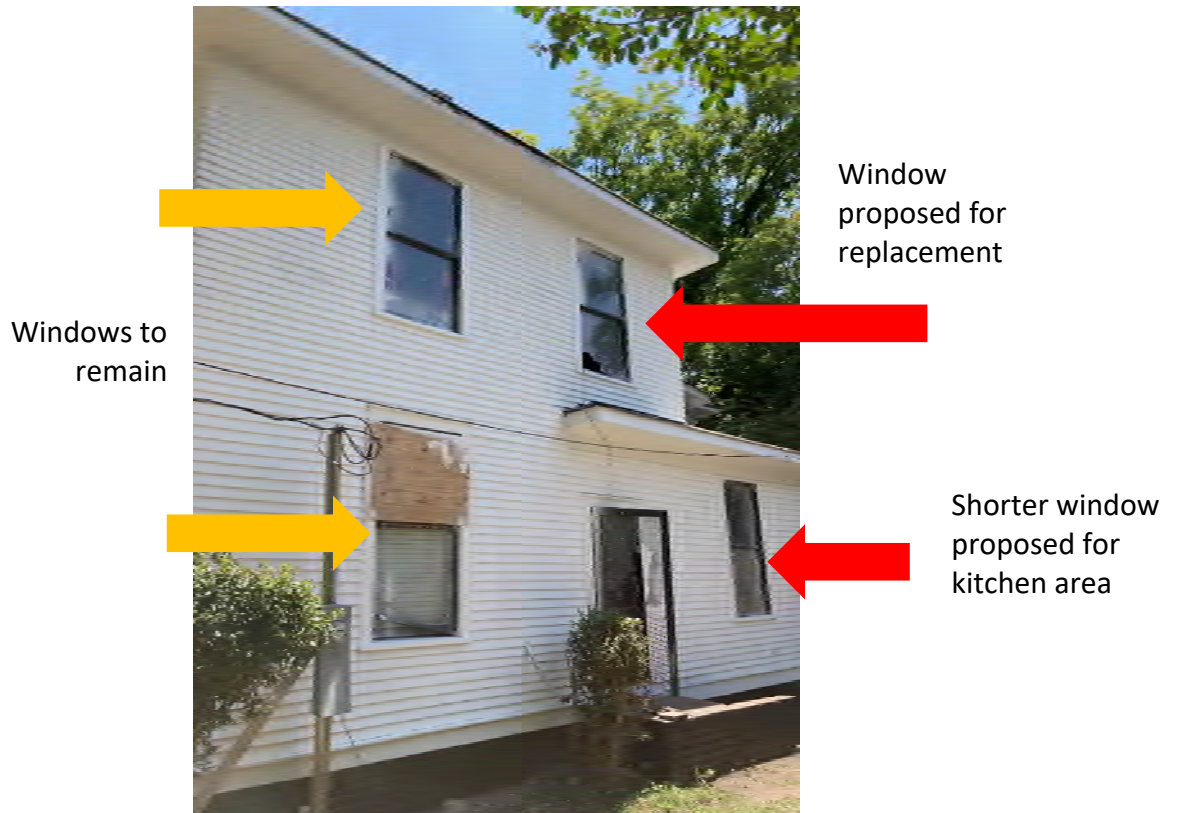
Right secondary façade – front and rear

Windows: The replacement of the windows on the side and rear facades are not proposed to have any effects on the exterior appearance of the property. The owner would repair the windows on the front façade and the top and bottom windows to either side of the front façade as needed and use any salvageable remaining part of the other windows for these and any future repairs.

Windows: This request would create a positive impact on the surrounding historic district. The proposed work will improve the appearance of the structure by replacing a number of the side and rear windows that are in poor condition.

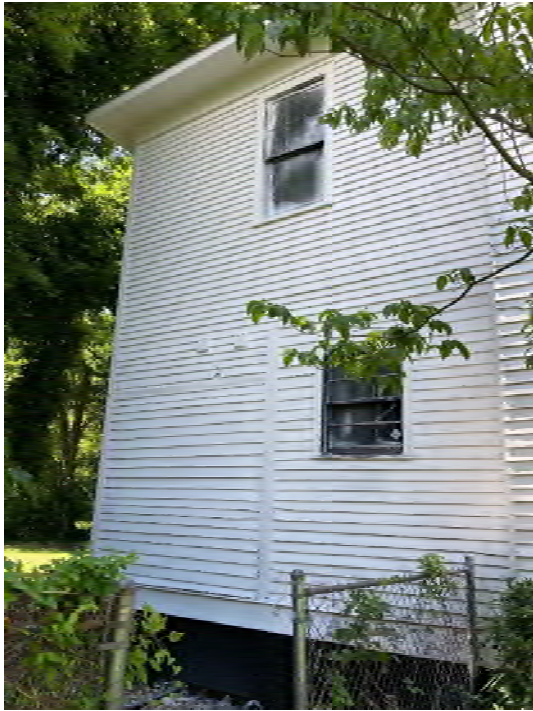
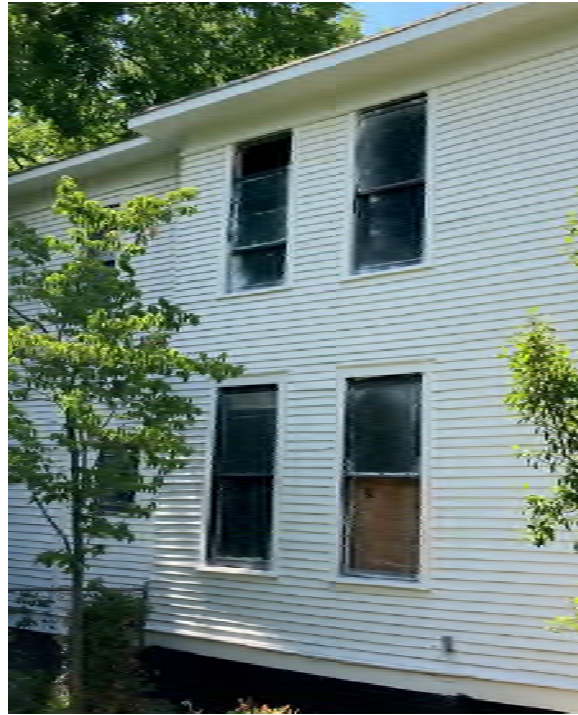
Left secondary façade, rear – all proposed to be replaced

The applicant will be replacing windows located on the side and rear with new vinyl replacement sash units of the same size. Neither the exterior nor the interior trim should be affected by this replacement.

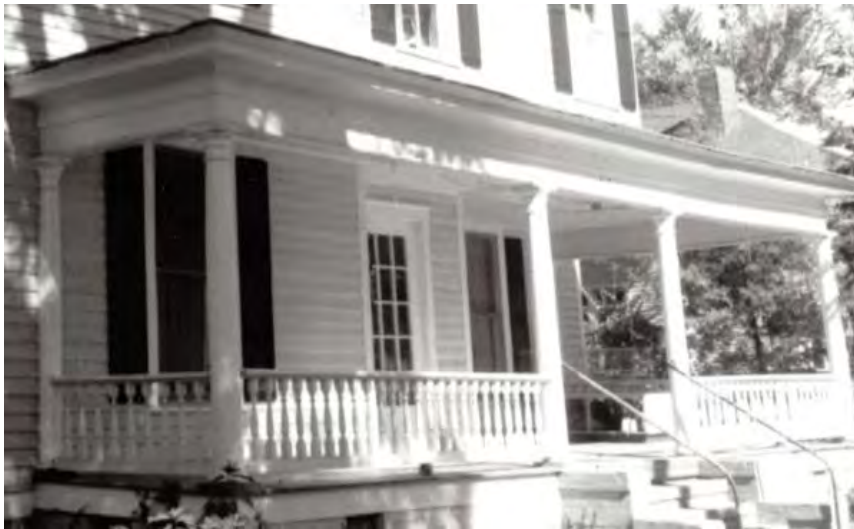
1988 Historic Resources Inventory image

As previously stated, the building was damaged by fire in 1992. Certificates of Appropriateness and building permits were issued for repairs but no details provided as to the exact work performed. Photocopies of photographs from 1994 show the condition of the front porch at that time, and it appears that the columns may have been replaced with those having a similar profile as those shown on the 1988 Historic Resources Inventory. One indicator that the columns are not original can be seen at the base of the half-columns attached to the wall where the base overhangs the porch floor. Staff has not been able to locate the original 1994 photographs, or any additional permits or photographs of the building prior to or between 1988 and 1994 which could provide additional information.

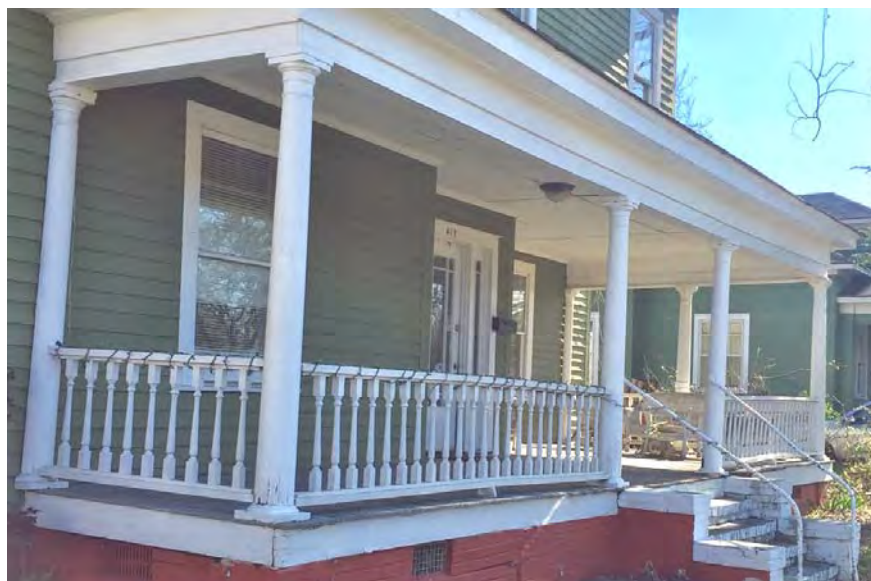
Current columns

Upon close examination of the columns in place, they are not solid wood (hollow core) and there is evidence of some rot at the base of the columns to either side of the steps and on the left side facing the porch. The half-columns attached to the wall and the full columns on the right side of the porch are in good condition.
